PROJECT PIPELINE

NV01: Fairfax County Route 236 – Little River Turnpike Final Report

From Prosperity Avenue to Wakefield Chapel Road

Final Report
October 2022

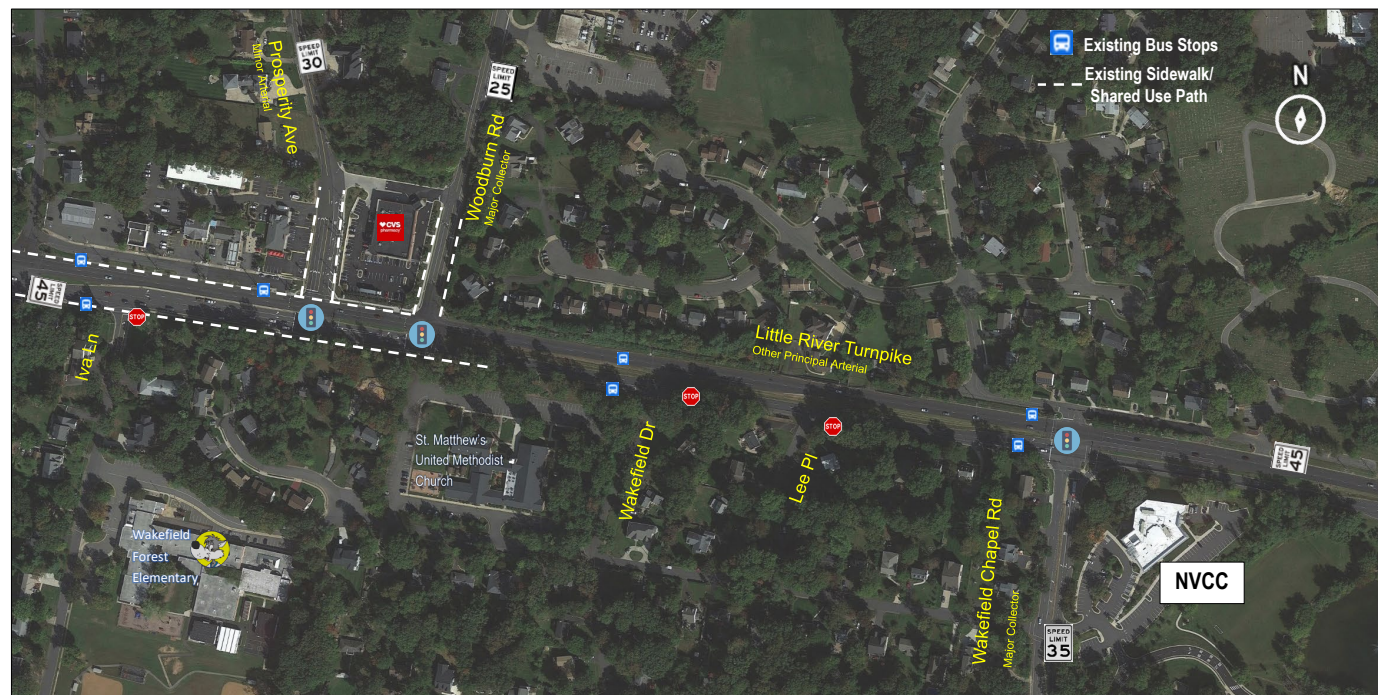
Figure 4: Route 236 Study Area Map

The Route 236 (Little River Turnpike) study corridor from Prosperity Avenue to Wakefield Chapel Road is located in Fairfax County, Virginia, and runs for approximately 0.4 miles in an east-west direction. The Route 236 corridor is classified as an other principal arterial road within the study area, with a posted speed limit of 45 MPH. The corridor provides access for residential areas to the west to I-66 and to I-395 and I-495 to the east. Route 236 within the study area is a four-lane divided roadway, with a grass median and turn lanes present at both the signalized and unsignalized intersections. The area immediately surrounding the study area is primarily residential, with a small amount of commercial development at the western end of the corridor. A map detailing the study intersections along Route 236 is shown below in **Figure 4**.

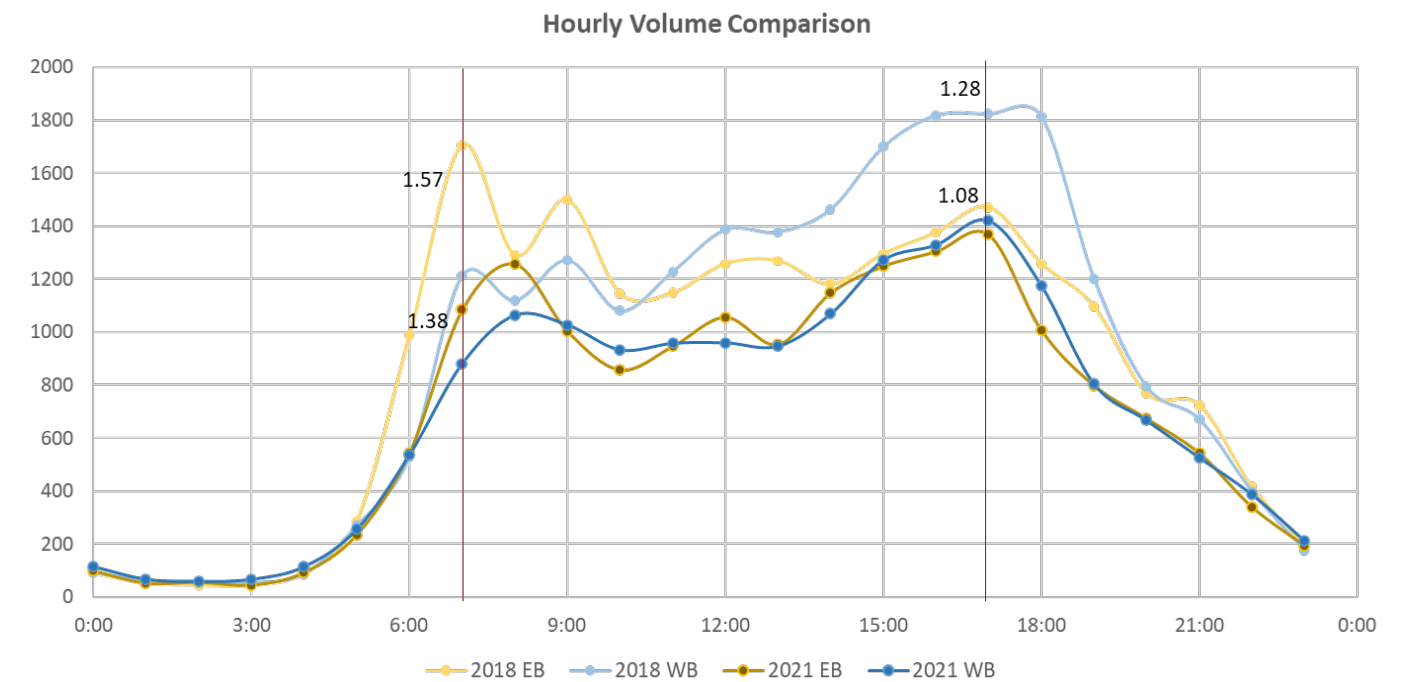
Figure 6: Traffic Volume Adjustment Factors

impact of COVID on traffic volumes. The impact of COVID on traffic volumes and the adjustments factors are shown in Figure 6.

EB	WB
AM Adj	1.57	1.38
PM Adj	1.08	1.28

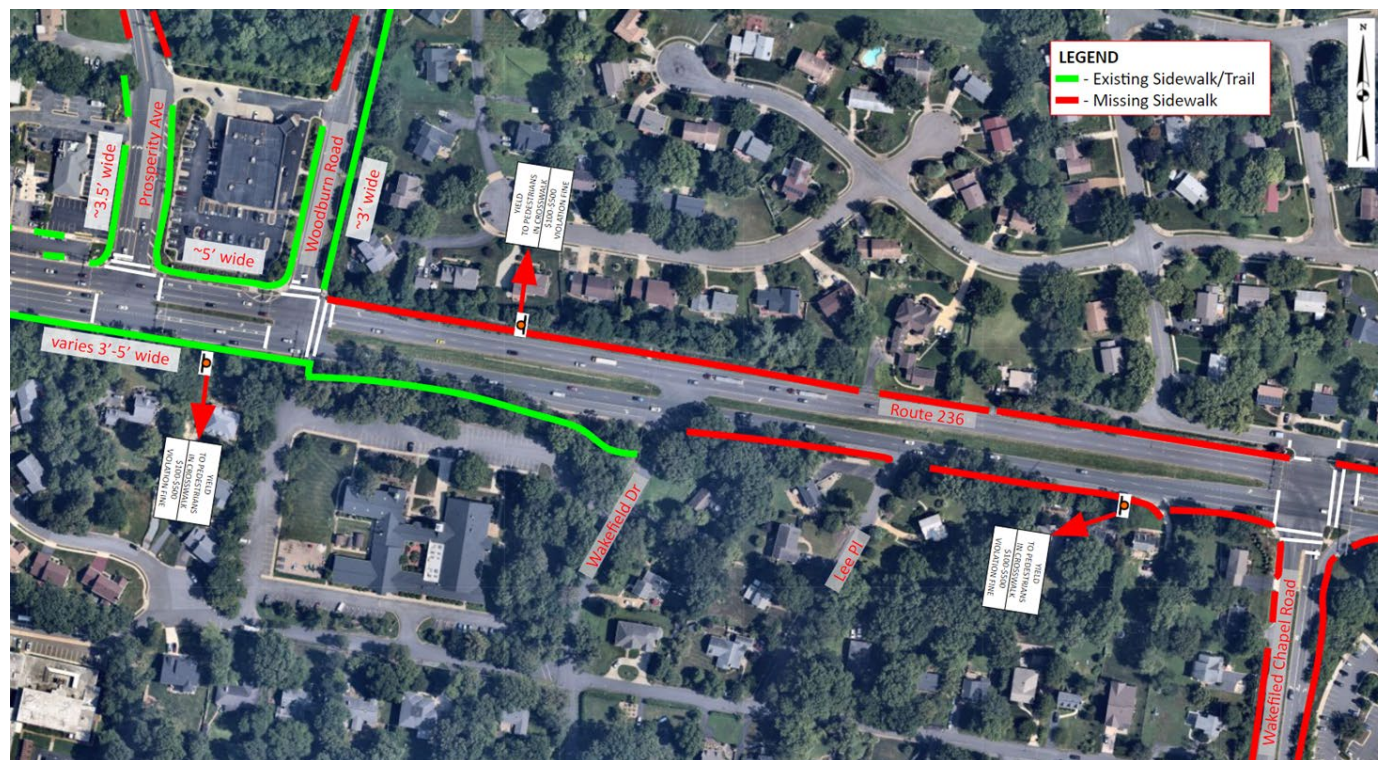
Figure 9: Pedestrian and Bicycle Network Overview.

In an effort to identify the needs with respect to accessibility, the study team reviewed existing conditions for pedestrian and bicycle accommodations. Sidewalks only exist at the western end of the Route 236 study corridor and there are no safe waiting areas at bus stops along the corridor. Some curb ramps and pedestrian push buttons are not Americans with Disabilities Act (ADA) compliant due to a lack of an accessible route for wheelchairs and/or do not meet distance standards. The paved shoulders are discontinuous and adjacent to vehicular travel lanes with no physical separation and therefore, do not safely accommodate bicyclists. An overview of the pedestrian and bicycle network is shown in **Figure 9**.

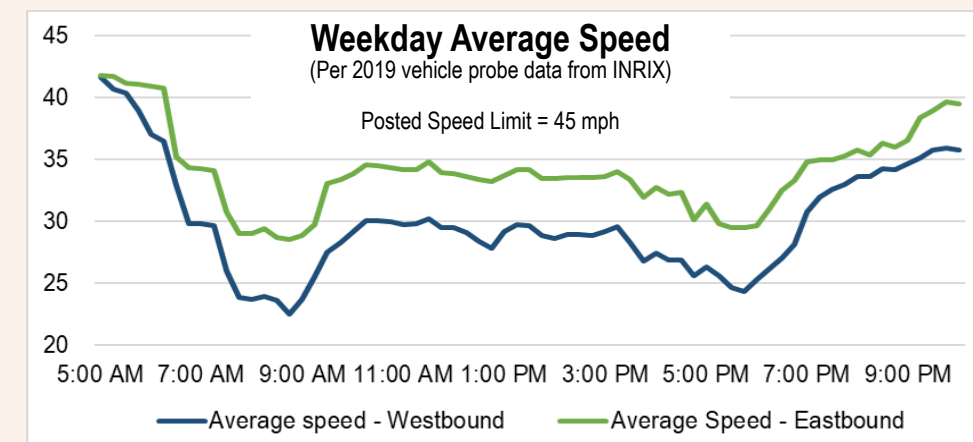
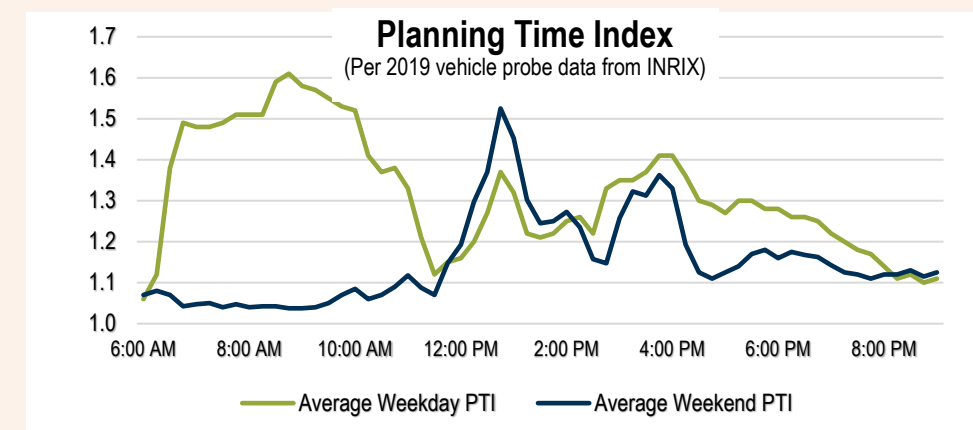
Figure 10: Corridor Operations and Safety Needs and Diagnosis

Traffic flow along the corridor

- High variability in average travel speeds along the corridor during the rush hours between 7 am – 10 am and 4 pm – 6 pm.
- Westbound direction experiences lower speeds and more congestion than the eastbound direction, which is worse during the AM rush hours compared to the PM rush hours.
- Slower speeds increase travel times and delay, causing congestion related increases in fuel consumption and air polluting emissions.
- Travel reliability decreases as the variability in average travel speeds increases requiring travelers to plan additional time to reach their destinations on time.

Planning Time Index (PTI) is a travel time reliability measure. It is the ratio of the 95th percent travel time to the free flow travel time.

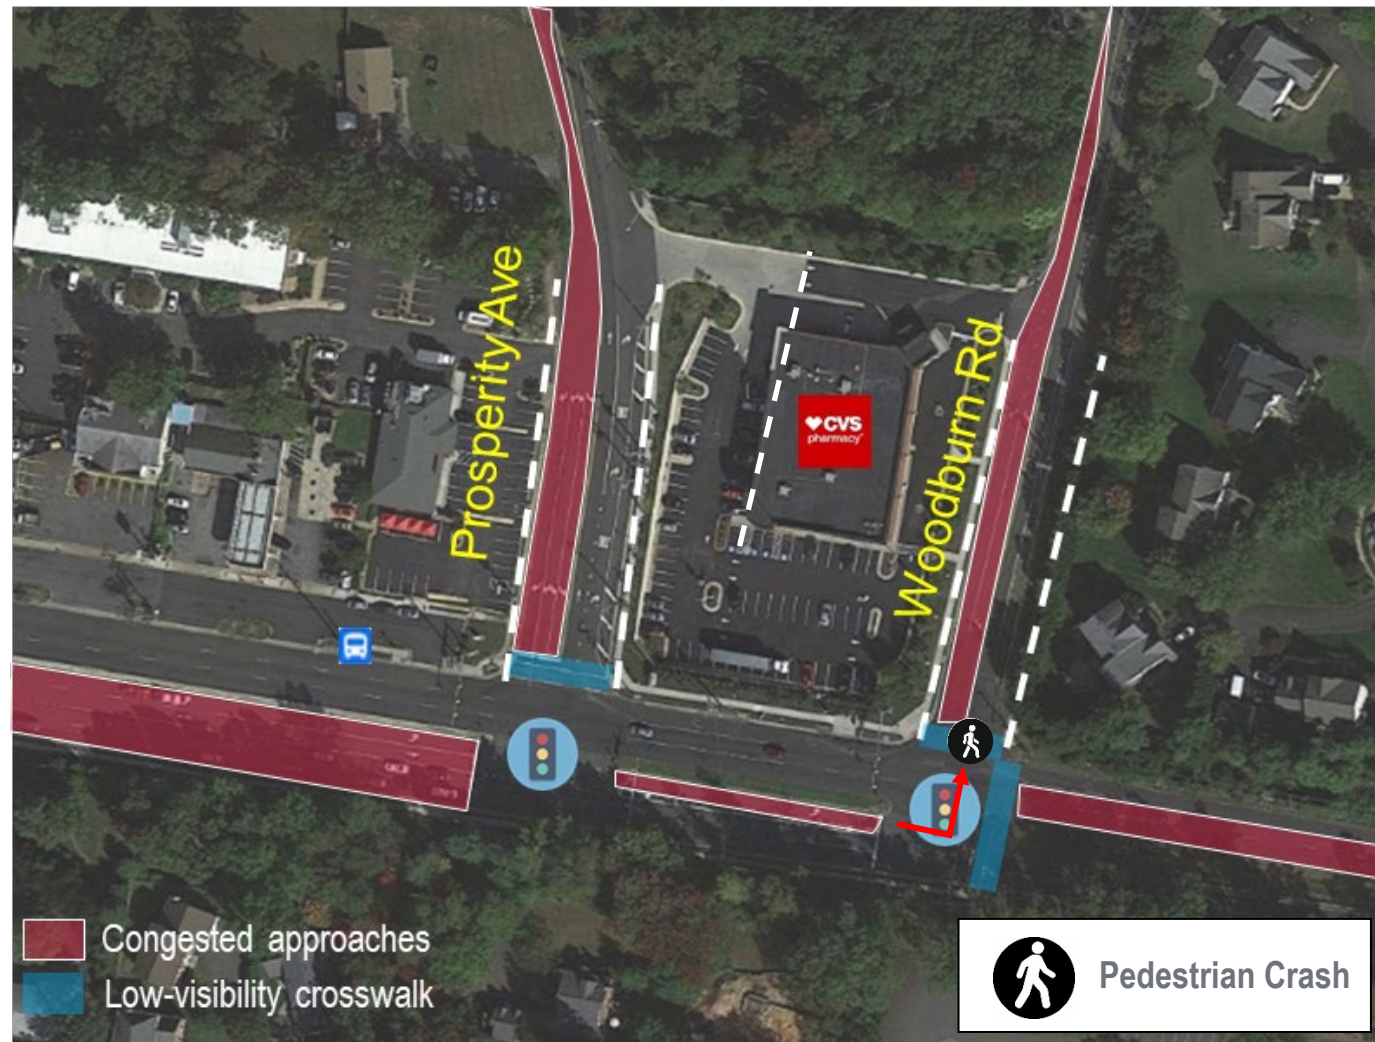
Prosperity Avenue and Woodburn Road Operation and Safety Needs and Diagnosis Summary:

At Prosperity Avenue, eastbound left turn and southbound movements operate with excessive delays and queues (AM and PM). At Woodburn Road, eastbound left turn (AM and PM), westbound through lanes (AM), and southbound (AM and PM) movements operate with excessive delays and queues.

Angle and rear-end crashes at the intersections. Congestion is suspected to be a primary contributor. The eastbound traffic signal operates with the 'left turn must yield to through vehicles' mode, which might cause left-turn related angle crashes.

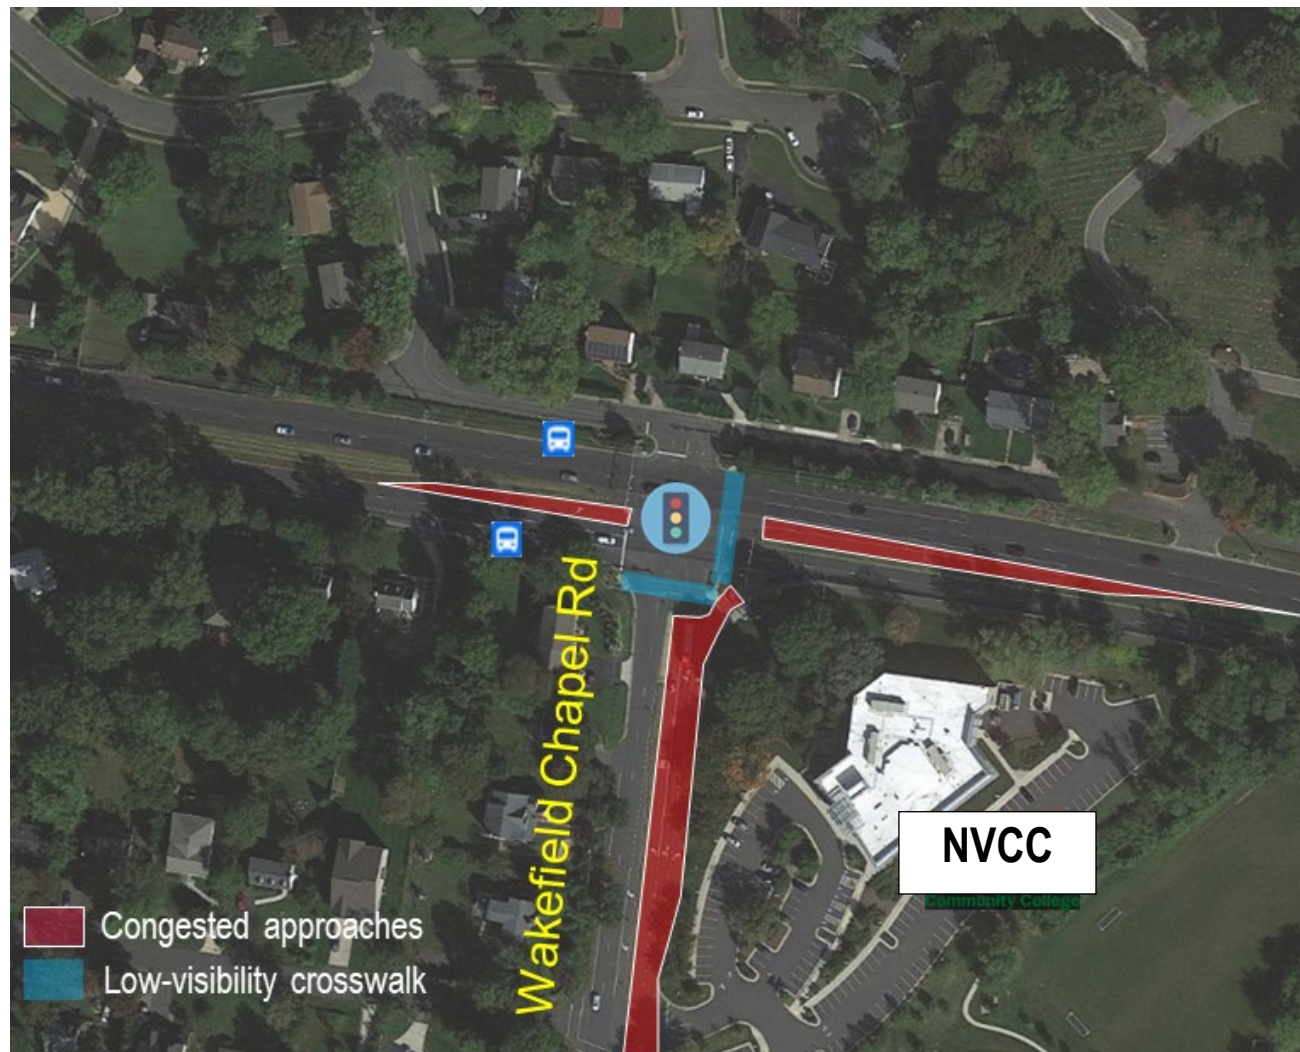
Wakefield Chapel Road Operation and Safety Needs and Diagnosis Summary:

Eastbound and westbound left turns and northbound movements operate with excessive delays and queues at Wakefield Chapel Road (AM and PM).

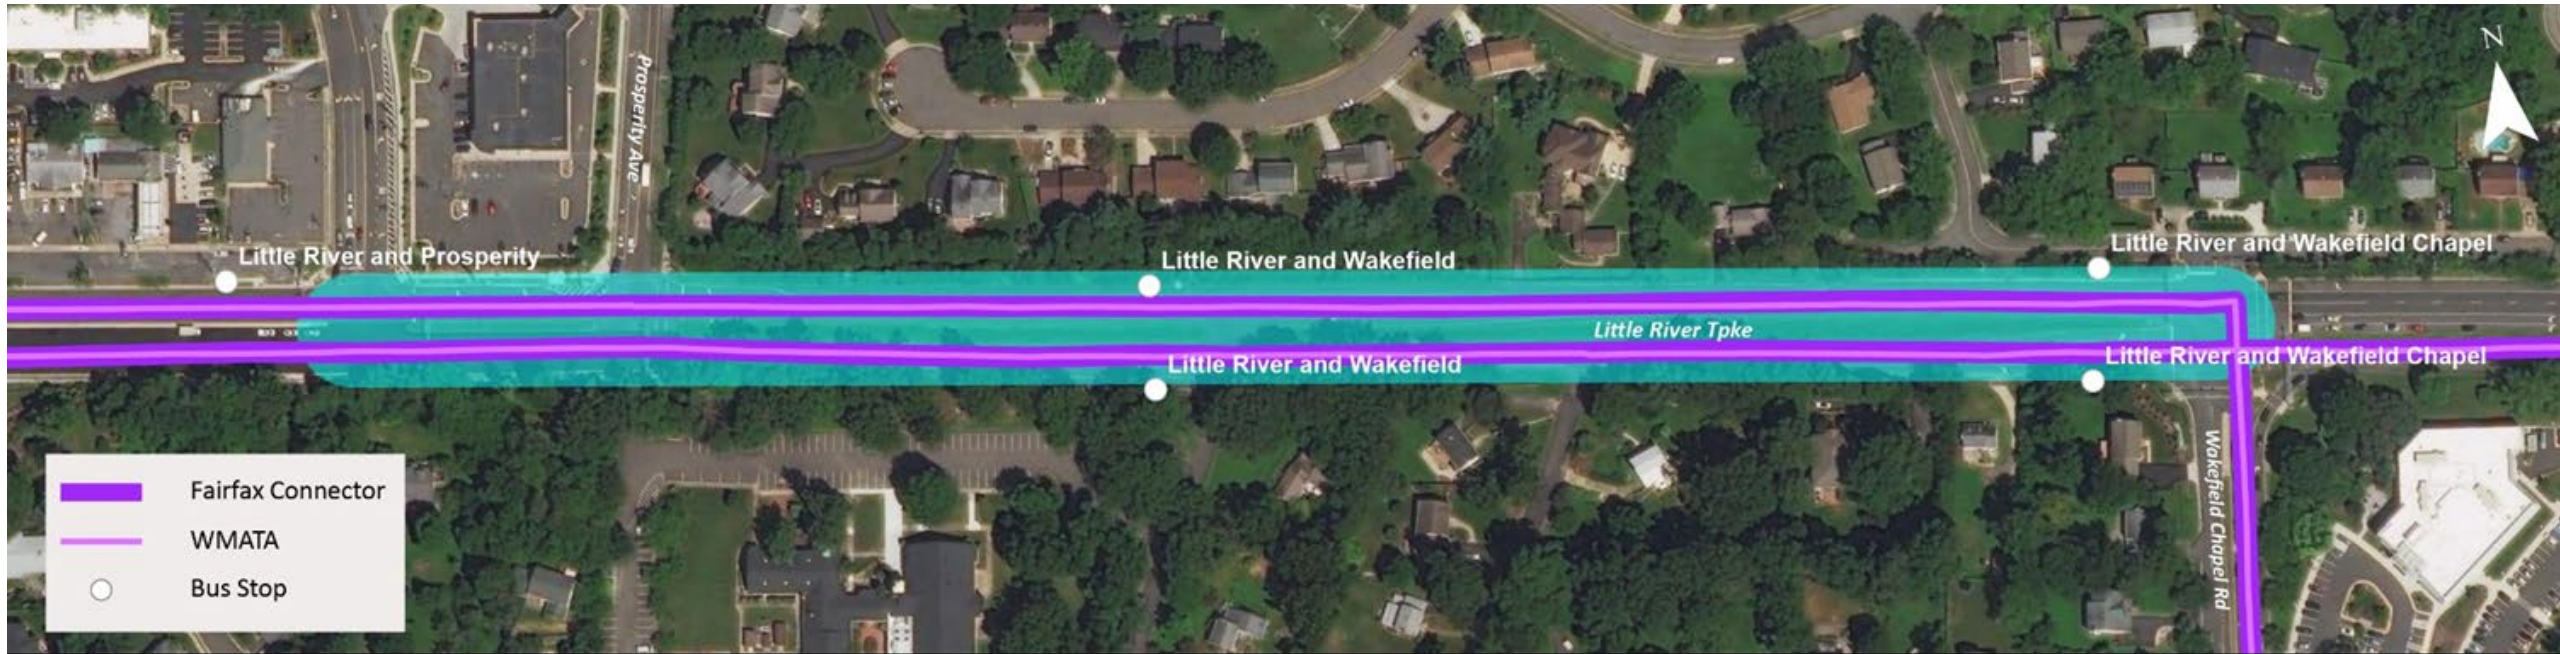
Figure 15: Rail, Transit, and TDM Needs and Diagnosis

Rail, Transit, and TDM Needs and Diagnosis Summary:

- No rail infrastructure
- Fairfax County Commuter Services, Vanpool Alliance, and DRPT Programs (vanpool, carpool, etc.)
- No park and rides in area
- No bike-sharing or scooter programs
- Metrobus 29K, 29N
Fairfax Connector 835
- 5 shared stops; no benches or shelters;
1 ADA accessible stop (Prosperity)

The rail, transit, and TDM needs identified by the study team are presented in **Figure 15**.

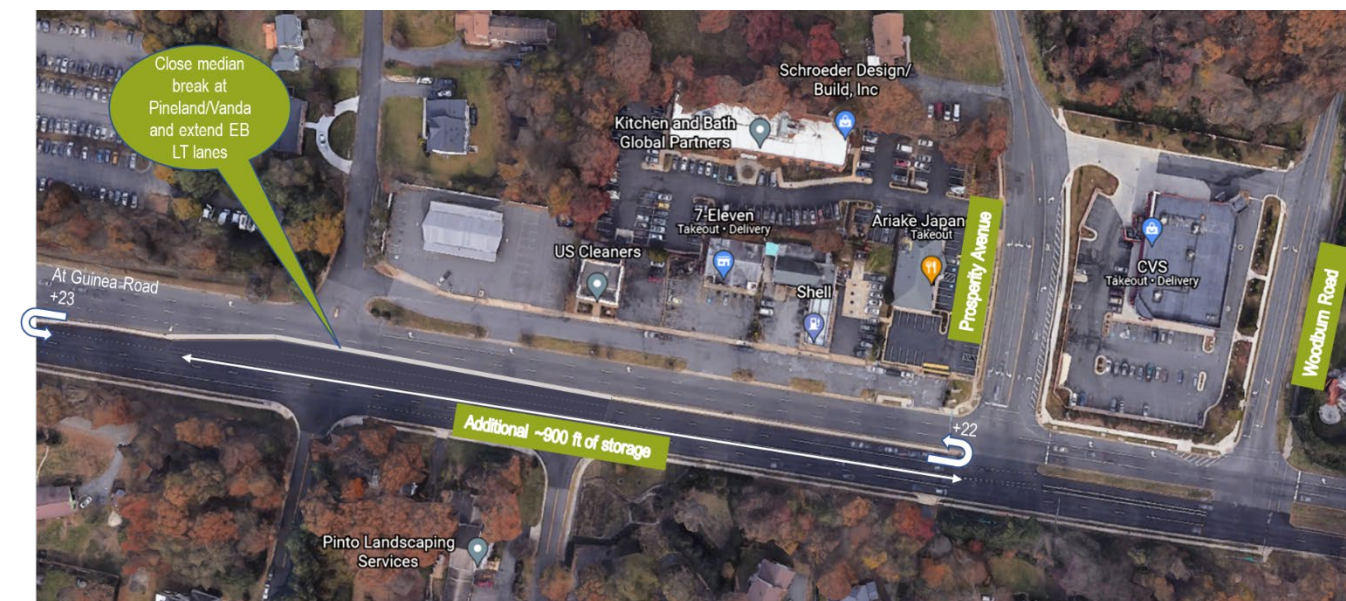
Figure 19: Eastbound Left Turn Lane Extension

This alternative would extend the eastbound left turn lanes along Route 236 at Prosperity Avenue to provide additional storage and prevent queue spillovers to help with the traffic flow and safety along the eastbound direction. This alternative required closure of the Pineland Street/Vanda Lane median break and would make this intersection a right-in right-out. This alternative was ruled out since it provided insufficient benefits to justify the cost and the impact to the community. A concept sketch of this alternative is shown in Figure 19.

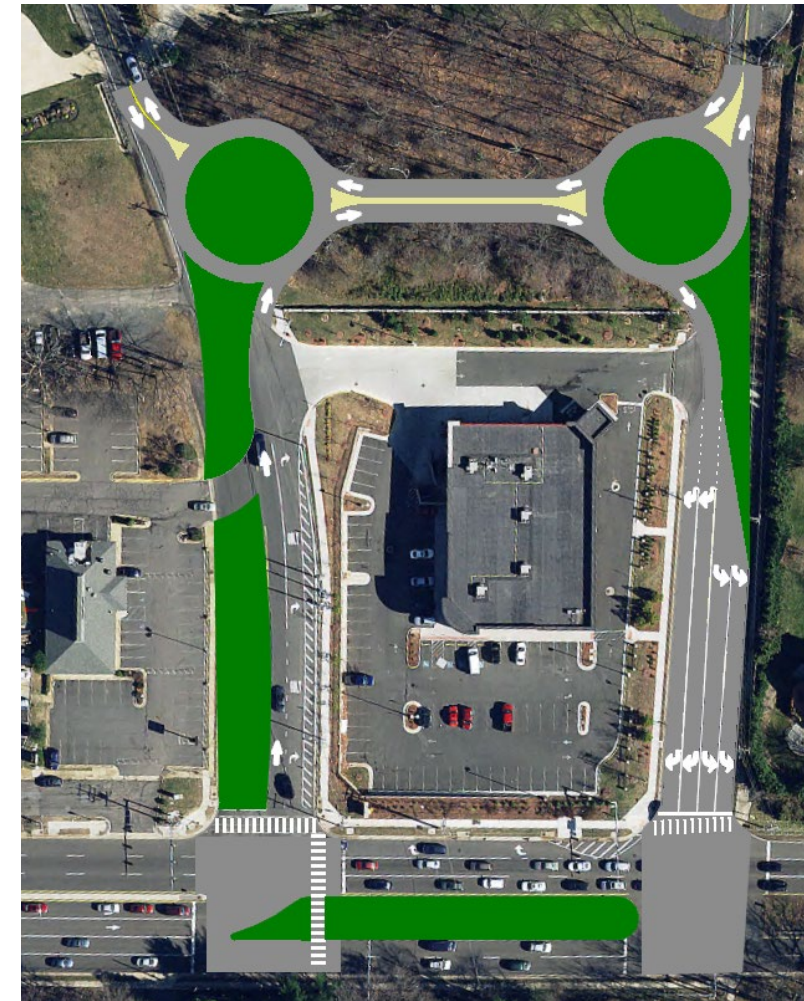
Figure 20: Split Intersection Configuration #1

Avenue. This alternative provided the opportunity to run the eastbound left turn movement concurrently with the southbound left turn movement, which would reduce the number of signal phases and provide the opportunity to reduce cycle length. This alternative was ruled out due to the extremely high southbound right turn volume in the PM peak hour that would accumulate at the Prosperity Avenue signal after turning onto Route 236, resulting in long queues and high delay. A concept sketch of this option is shown in Figure 20.

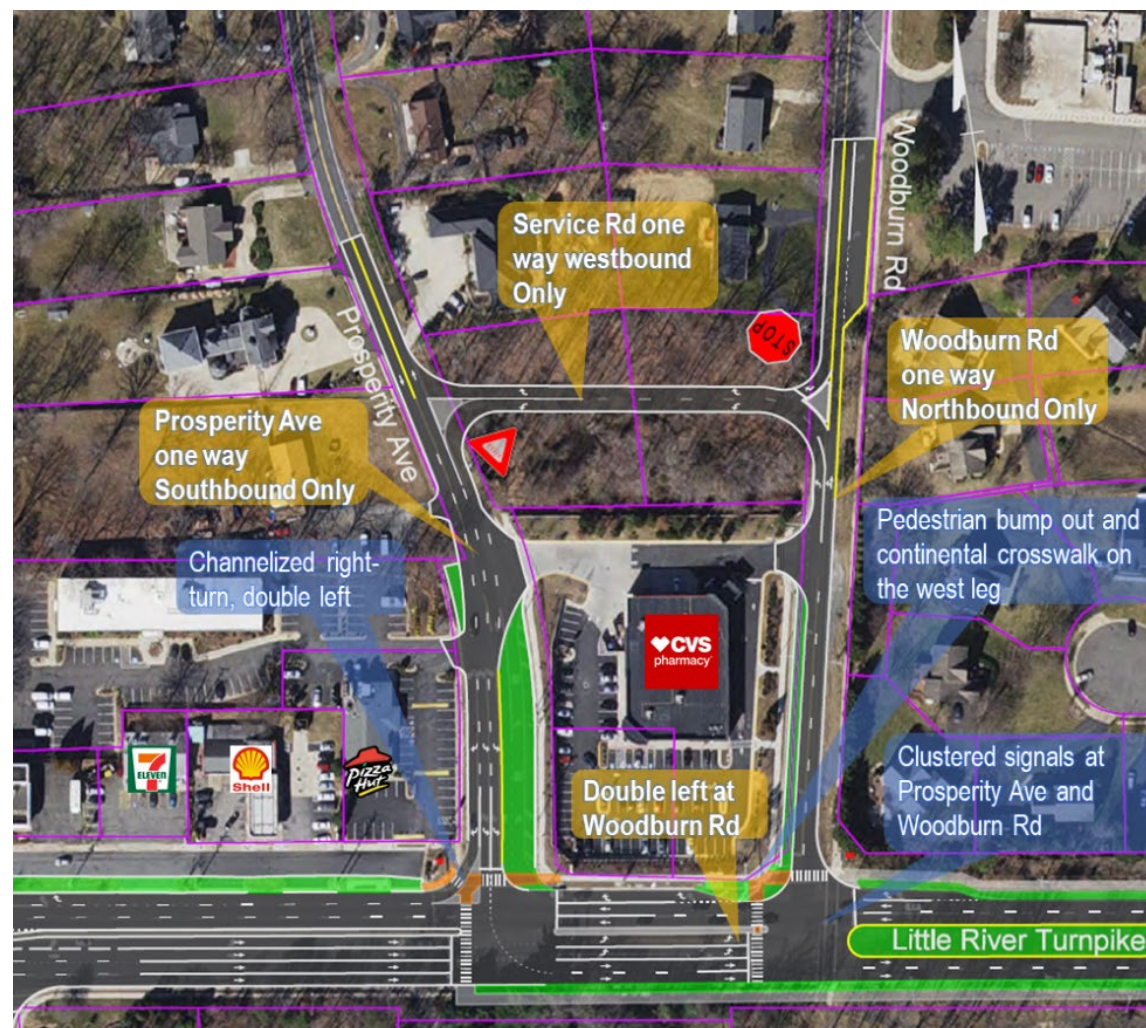
Figure 21: Split Intersection Configuration #2

Similar to the proposed Tier 3 improvements and the Split Intersection Configuration #1, this alternative would connect Prosperity Avenue and Woodburn Road through a new roadway. The difference between this alternative and Configuration #1 is that Prosperity Avenue would be converted to a one-way roadway travelling southbound and Woodburn Road would be converted to a one-way roadway travelling northbound. Since the eastbound left turn movement onto Prosperity Avenue was closed, all the left turn volume would use Woodburn Road. This alternative provided additional storage for the eastbound left turn movement and relocated all the southbound right turn volume to Prosperity Avenue, allowing them to bypass the signal and preventing them from accumulating on Route 236. This alternative was ruled out since it did not provide enough benefits to justify its cost and impact on the community. A concept sketch of this option is shown in **Figure 21**

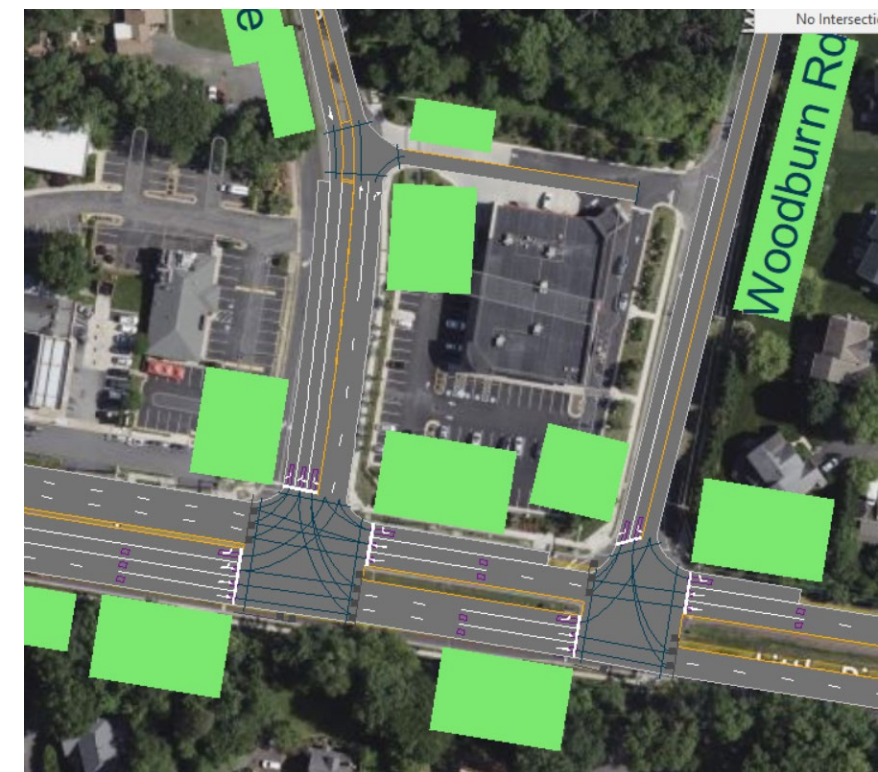
Figure 22: Double Eastbound Left at Prosperity Avenue

For this alternative, the eastbound left turn lane onto Woodburn Road that continues through Prosperity Avenue was utilized to make an additional left turn onto Prosperity Avenue (the left and through lanes were converted to a left and a shared left/through). Because of the additional lane, the left turn phasing was converted from permissive-protected to protected-only mode. This alternative did not provide major benefits for the traffic flow and was removed. A concept sketch of this option is shown in **Figure 22**.

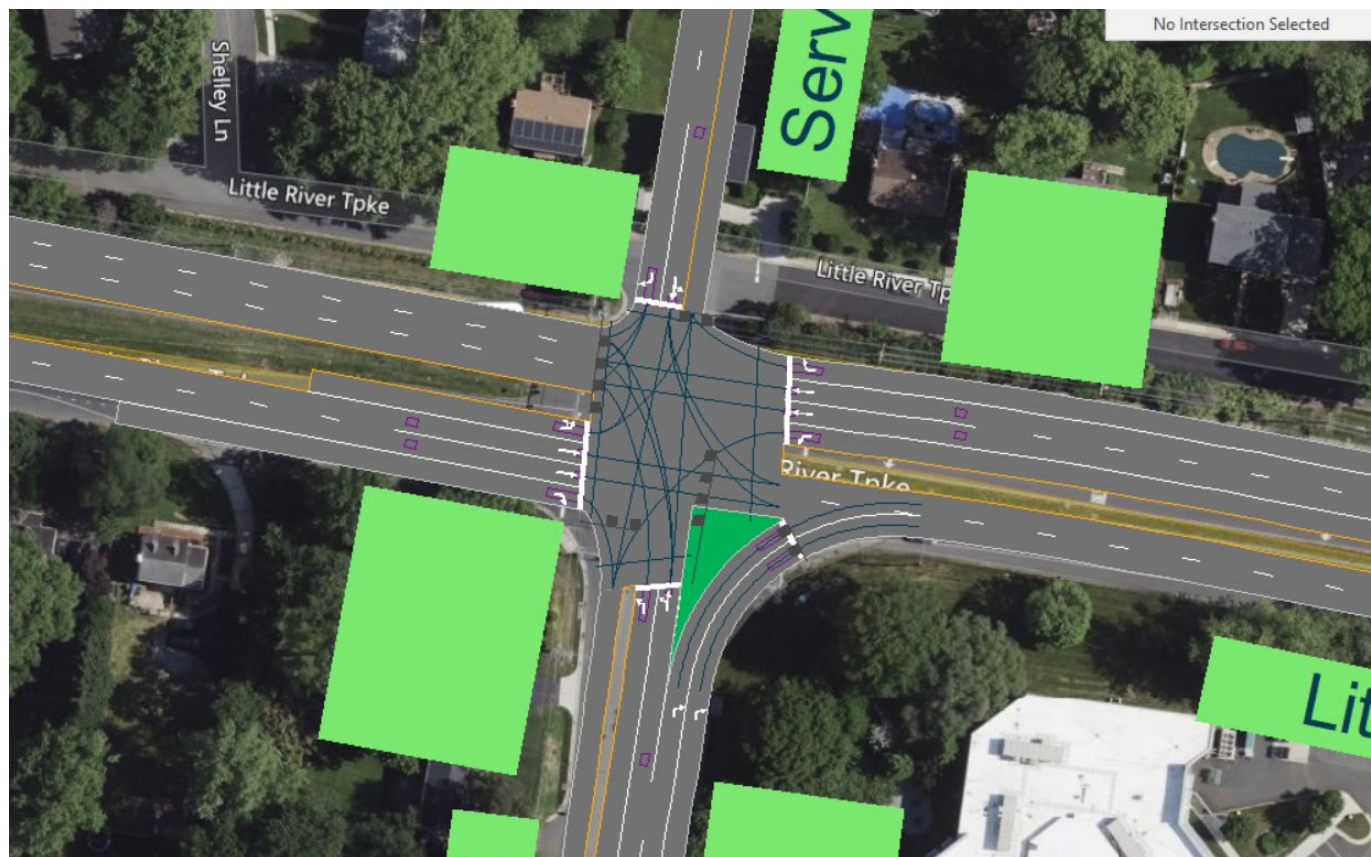
Figure 23: Single Westbound Left Turn Lane at Wakefield Chapel Road

This alternative was similar to the proposed Tier 2 and Tier 3 improvements at Wakefield Chapel Road, but the westbound left turn was reduced from two lanes to one lane to prevent median removal along Wakefield Chapel Road for fitting the additional northbound lanes. This alternative worked with acceptable delays and queues with the available traffic volumes used in the Synchro models, but it was removed since there were concerns with the westbound left turn volumes going onto NoVA Community College being underestimated, as traffic counts were collected during COVID. A concept sketch of this option is shown in **Figure 23**.

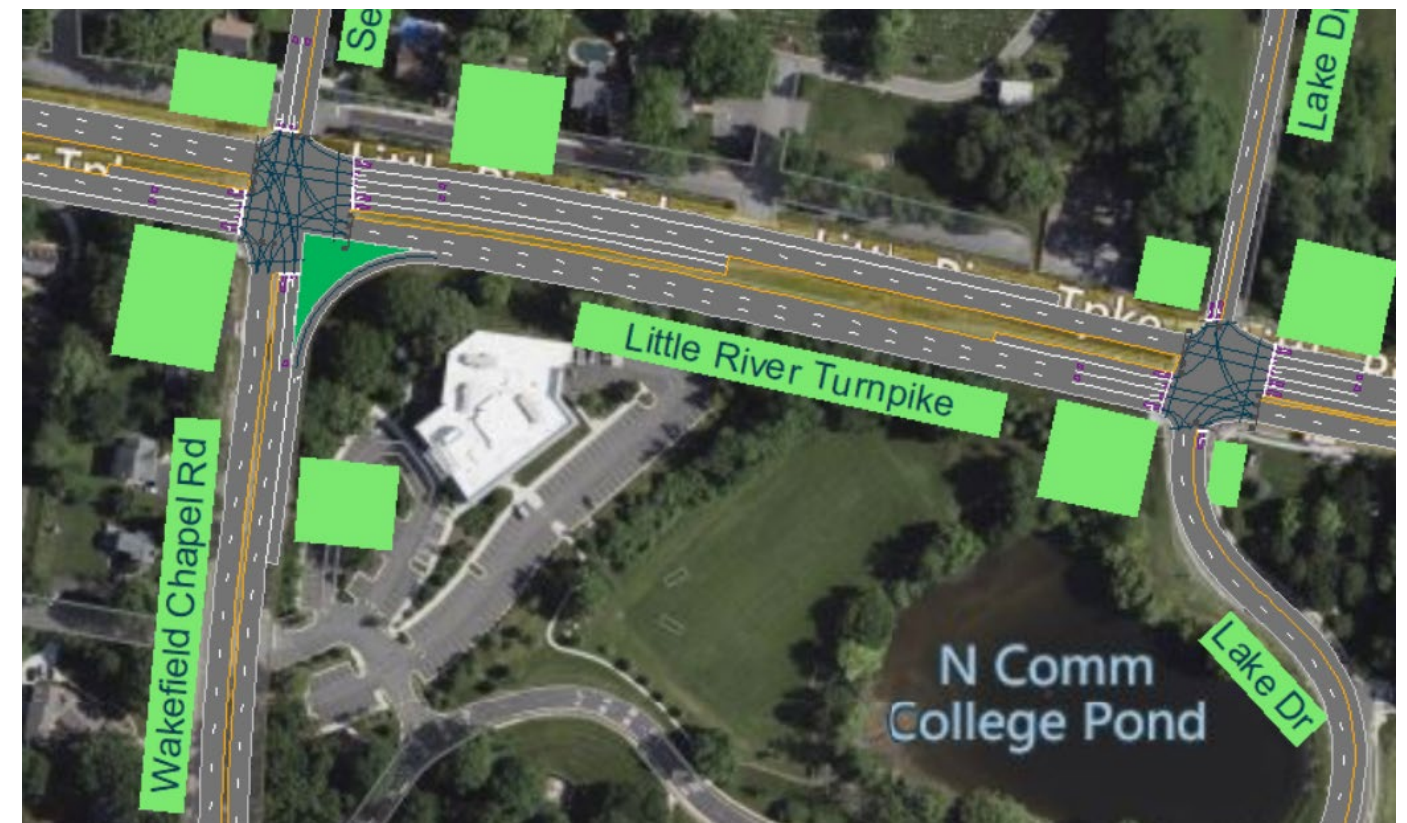
Figure 24: Wakefield Chapel Road Northbound Right Turn Receiving Lane

This alternative would add a receiving lane for the northbound right turn movement at Wakefield Chapel Road that continues until the next intersection at Lake Drive. It was ruled out since it did not provide sufficient benefits to justify the costs associated with construction and right-of-way acquisition. A concept sketch of this option is shown in **Figure 24**.

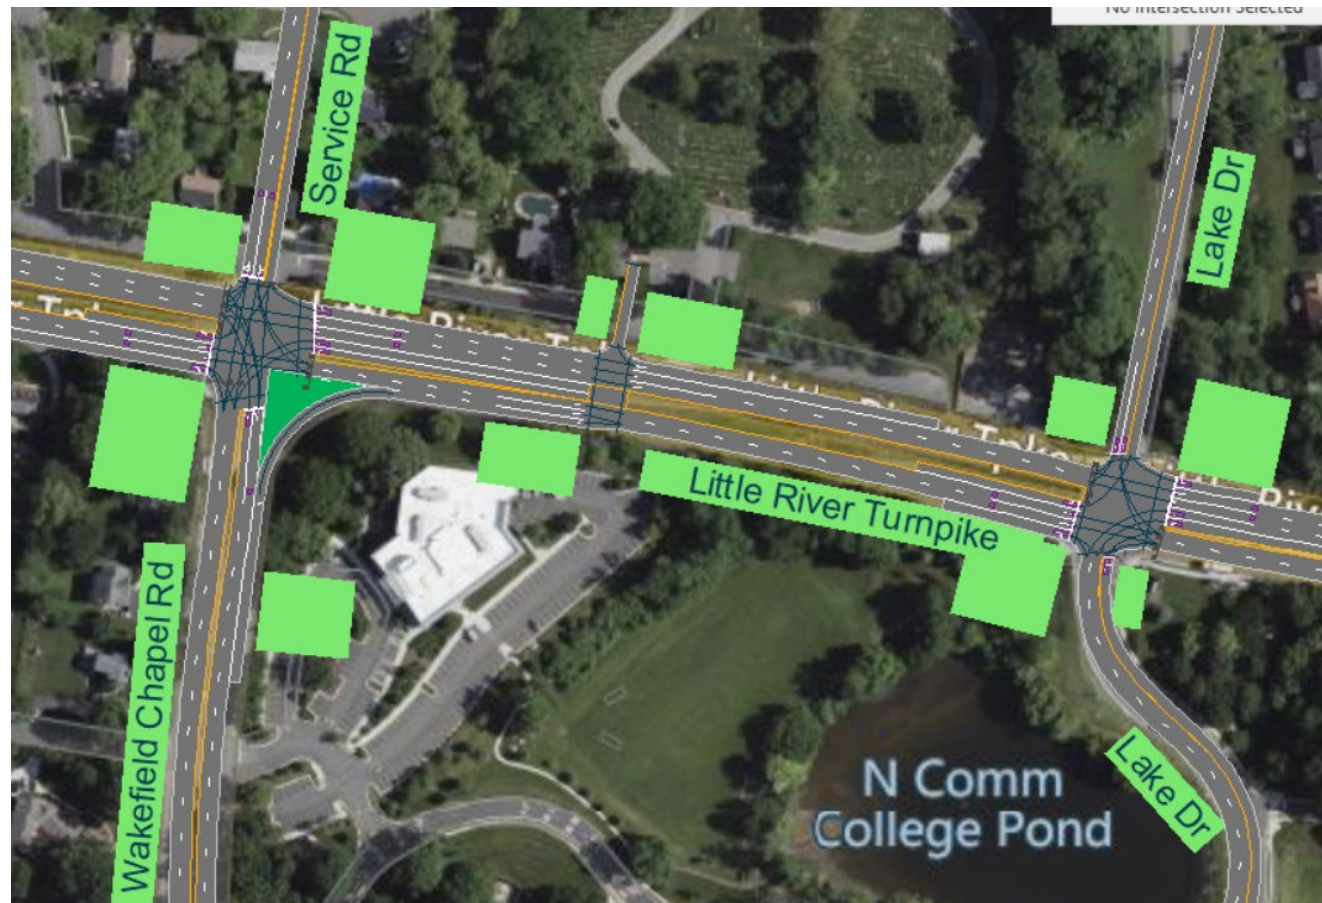
Figure 25: Wakefield Chapel Road Short Northbound Right Turn Receiving Lane

This alternative would add a shorter receiving lane for the northbound right turn movement at Wakefield Chapel Road that continues midblock and merges back to Route 236. It was ruled out since it did not provide sufficient benefits to justify the costs associated with construction and right-of-way acquisition. A concept sketch of this option is shown in **Figure 25**.

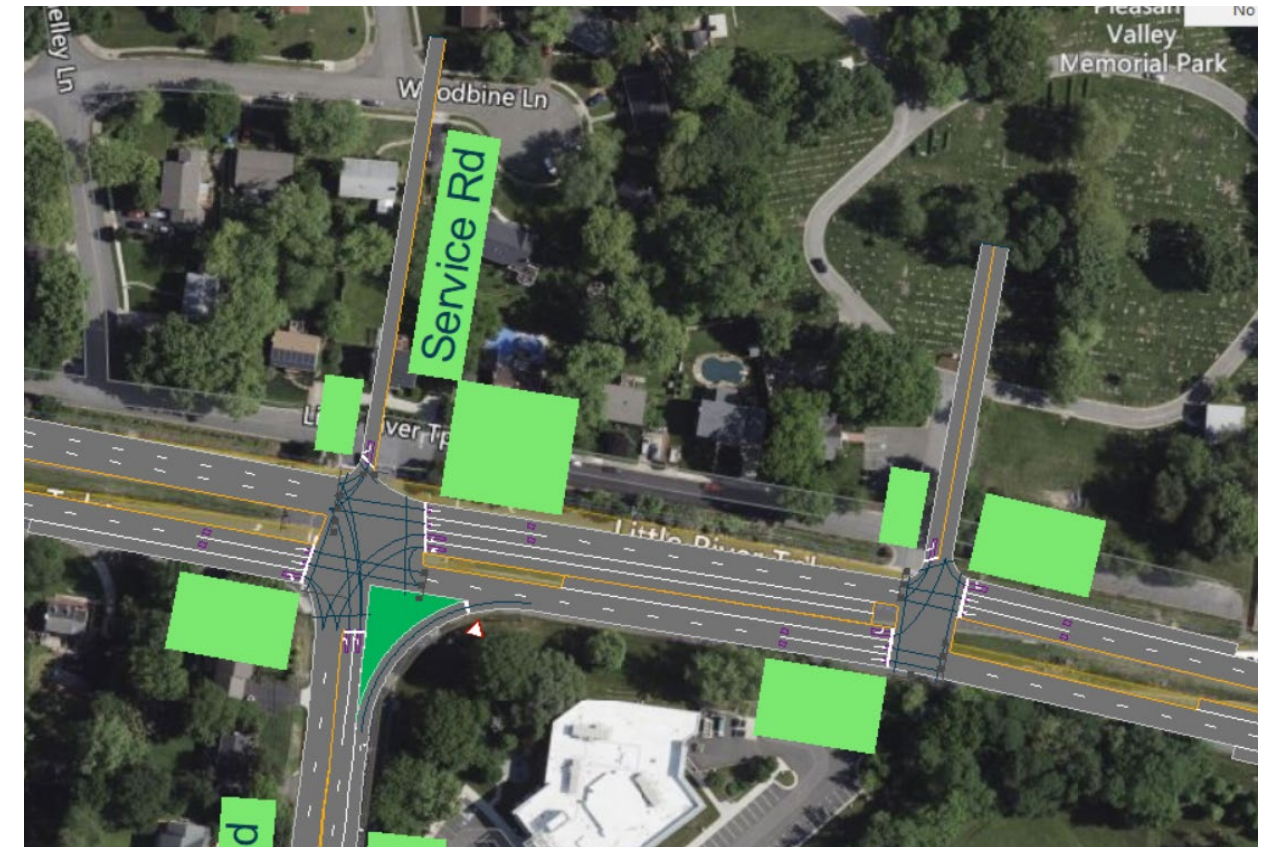
Figure 26: Wakefield Chapel Road North Leg Removal

This alternative would remove the north leg of the Wakefield Chapel Road intersection except for the right-out movement. All the restricted movements would use a new intersection to the east to access the Service Road. This alternative was ruled out since it did not provide sufficient benefits to justify the costs and the north leg volumes were considerably low that it did not provide major operational benefits. A concept sketch of this option is shown in **Figure 26**.

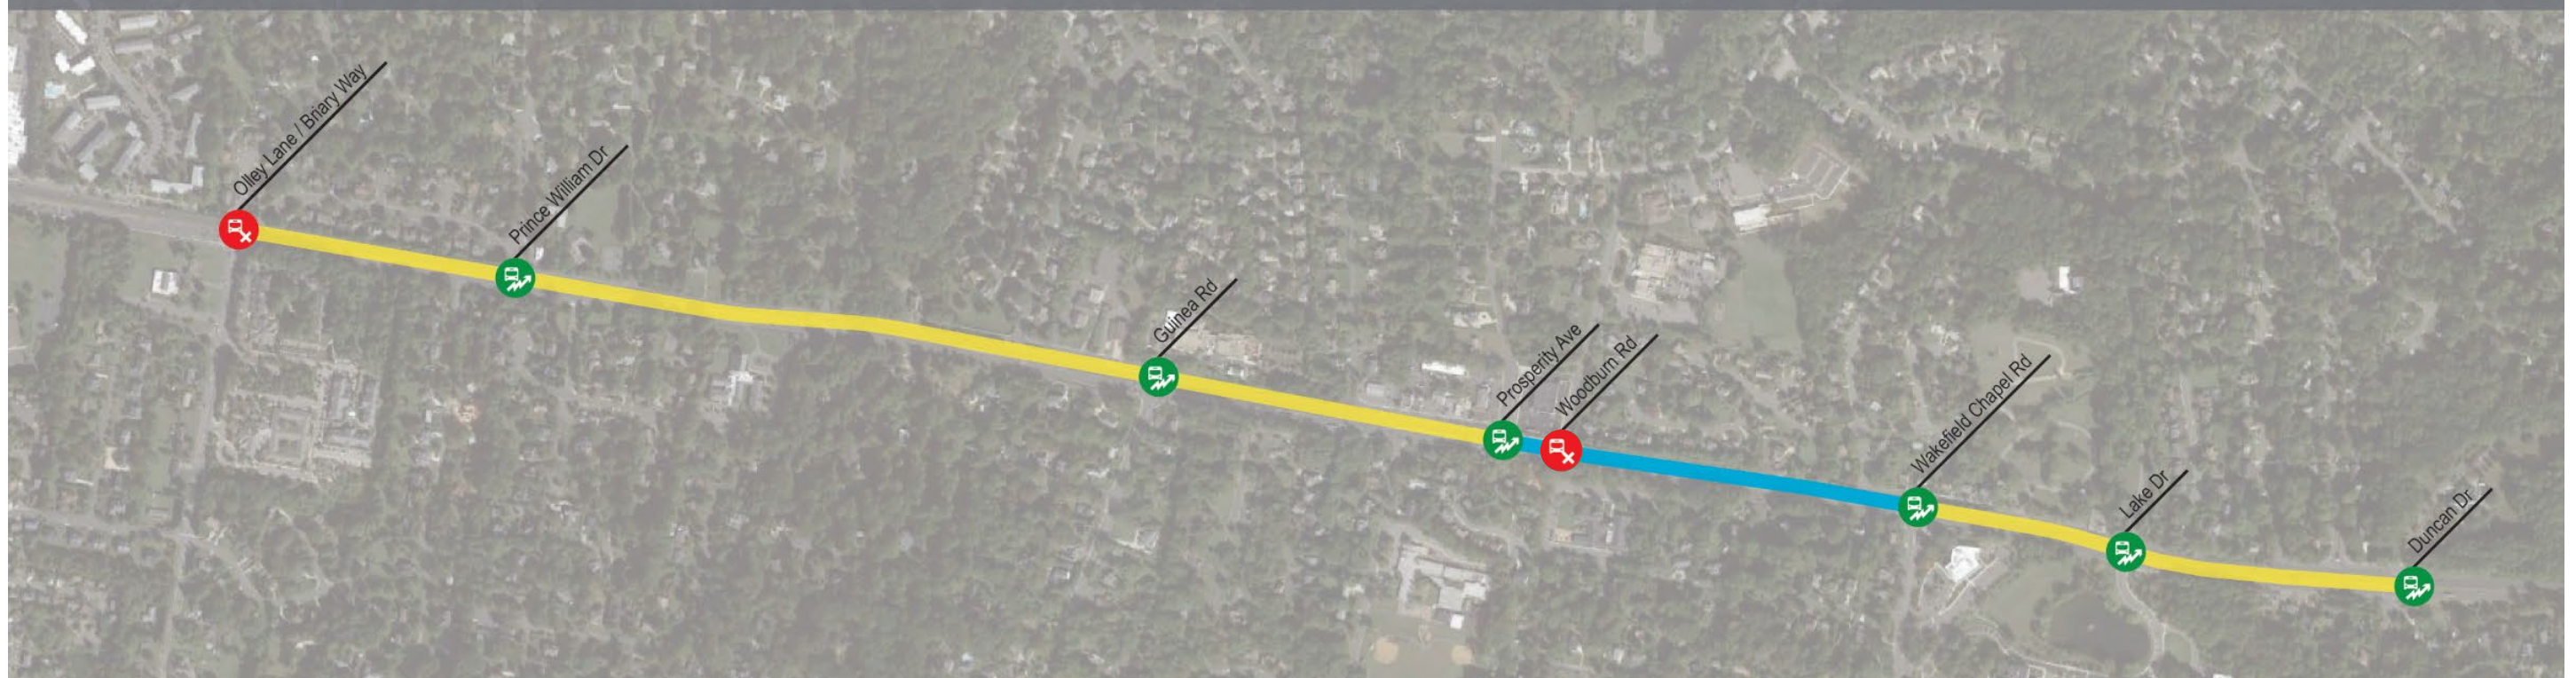
Figure 37: Feasible Queue Jump Locations

- Prince William Drive in the eastbound direction.
- Guinea Road in the eastbound direction.
- Prosperity Avenue and Woodburn Road in the westbound direction for Tier 1; not feasible for Tier 2 and Tier 3.
- Lake Drive in the eastbound direction.
- Duncan Drive in both directions.
