PHASE I - DIAGNOSIS AND PROBLEM IDENTIFICATION

TEAM 1 - TRAFFIC OPERATION AND ACCESSIBILITY NEEDS

Project Purpose, Goals, & Objectives

Analyze the operational and safety issues identified along Route 11/460 (West Main St), with a focus on safety, bicycle & pedestrian access, transit access, TDM, and congestion mitigation.

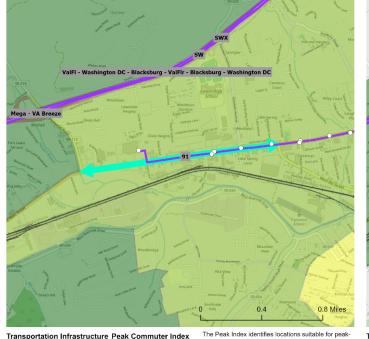
Park and Ride Locations Transit Stops

Park and ride lot located to the north of I-81 off VA 311 (approximately 3 miles north of study area)
